**SKY LIFT ROOF RISER HARDWARE**  
**Testing of Skylift and shade-sails hardware: Tipping, Uplift, and Hook**  
**Strength**

Department of Wood Science and Engineering  
Oregon State University  
234 Richardson Hall  
Corvallis, OR

October 2, 2012

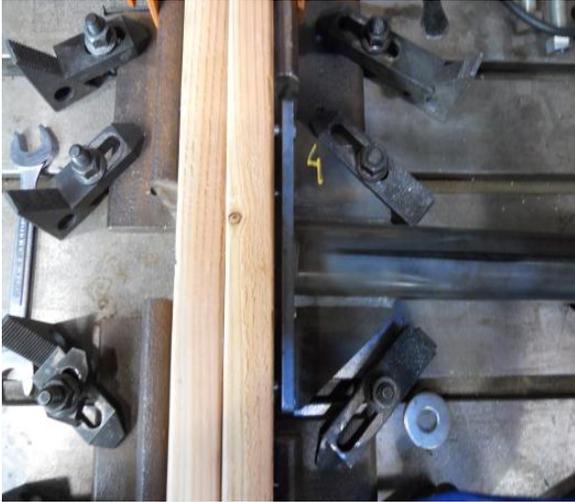
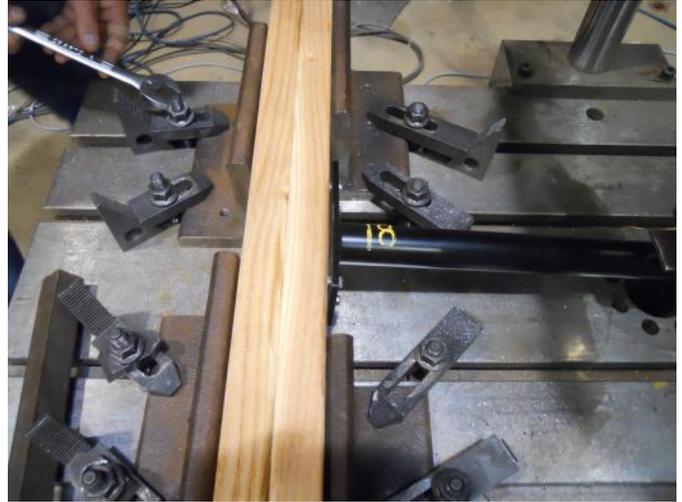
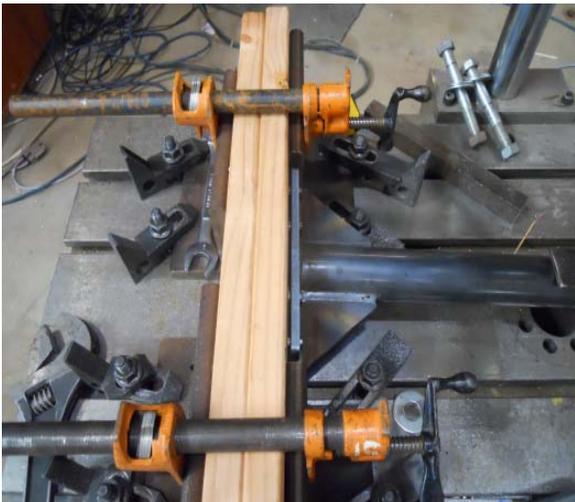
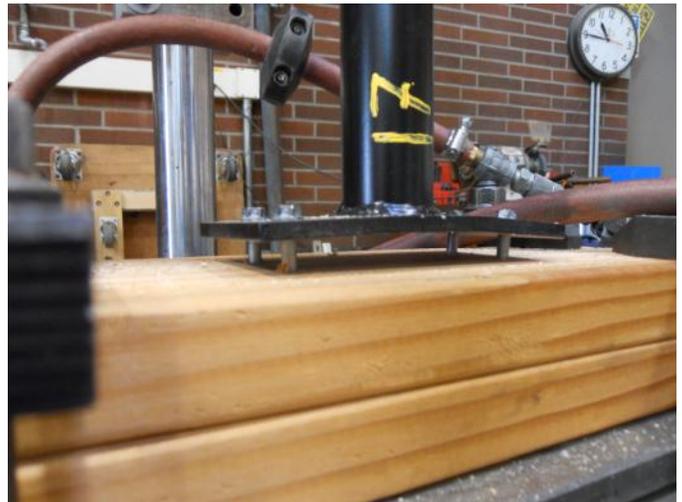
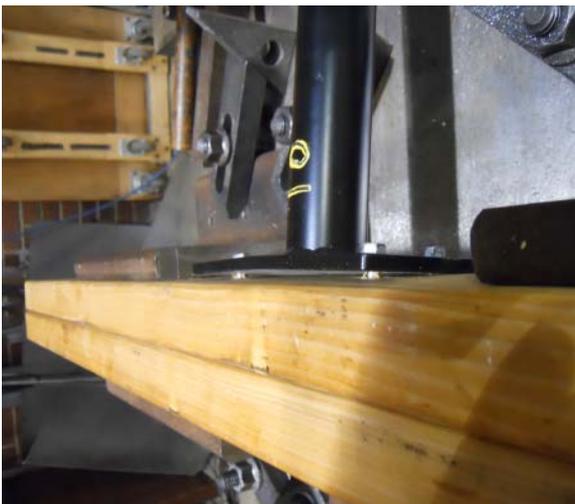
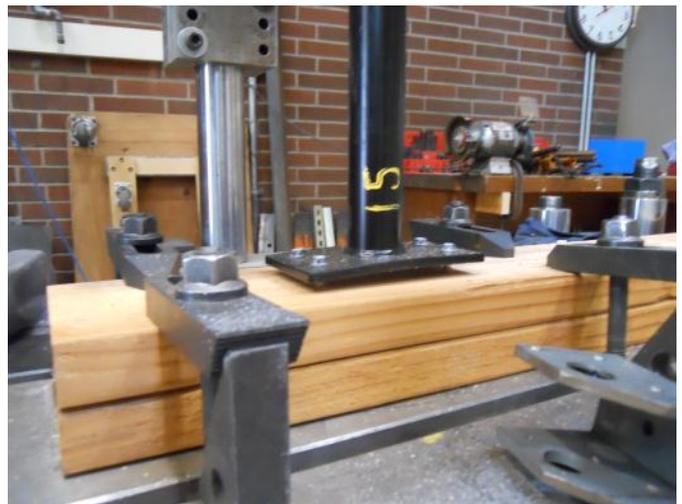
**Appendix: Picture of observed failure mode**

Uplift will be a major concern for the SL posts. The uplift as tested was on an average 5437 lbs. Details are presented in Table 2. This value is higher than the maximum allowable load as per the design sheets provided. The failure mode was pull out of the fasteners from the top plate of the wall, which was expected. There was slight bent observed in the cross beam holder during the test, which is a result of huge amount of load transfer that is taking place through that holder during testing for uplift.

The testing for the Skylift posts (SK24B) and Shade sails posts and shackle connections were conducted and their performance was evaluated. Both SL (SK24B) and SS (1 and 2) performed expectedly and adequately in tipping loads. The predominant failure mode was pulling out of the fastener connecting the base plate and the top plate of the wall. The shackles connecting the shade sails and posts performed adequately and failed in shackle yielding and pulled pin. The uplift for the SL posts exceeded the designed value and failure observations revealed pull out of the base plate – top plate fasteners.
